MODERN UNDERPINNING

DEVELOPMENT, METHODS
AND TYPICAL EXAMPLES

LAZARUS WHITE, C.E.
EDMUND ASTLEY PRENTIS, JR., E.M.

1917

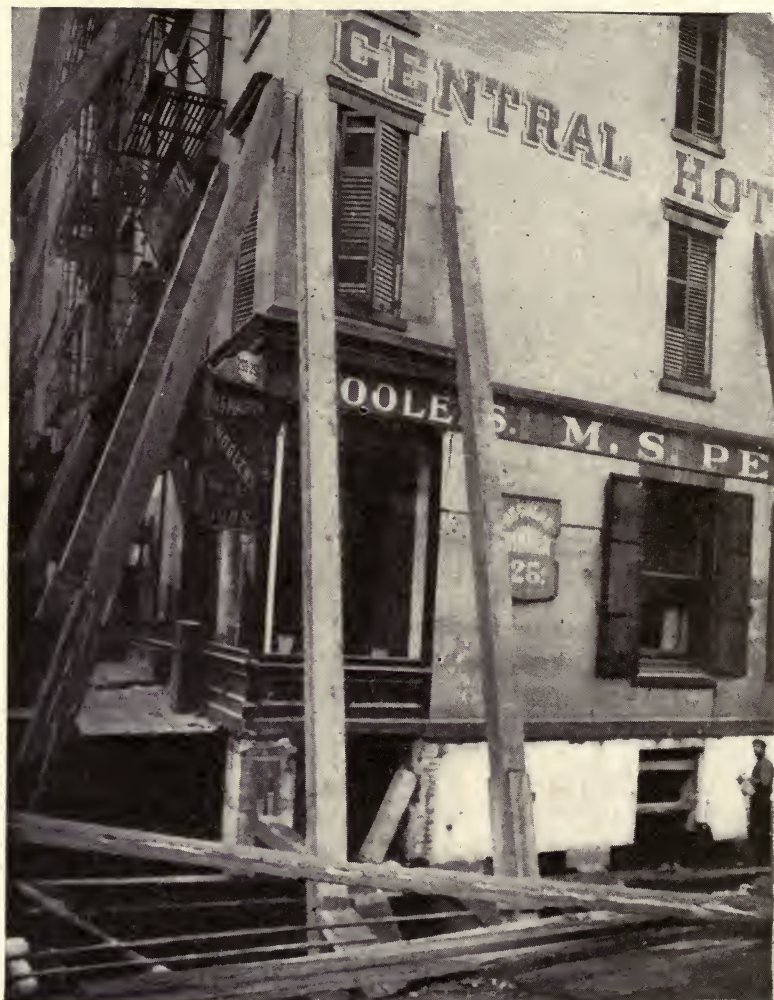
PLATE NO. 1. Method of Shoring Used in 1902 during Construction of the Subway in New York City

Note cracks in the brickwork. Compare this with the frontispiece as to street obstruction, etc.

This crude method, although usually preventing collapse, often seriously cracked the structure, and large settlements occurred despite the liberal use of screw-jacks at the base of the shores.

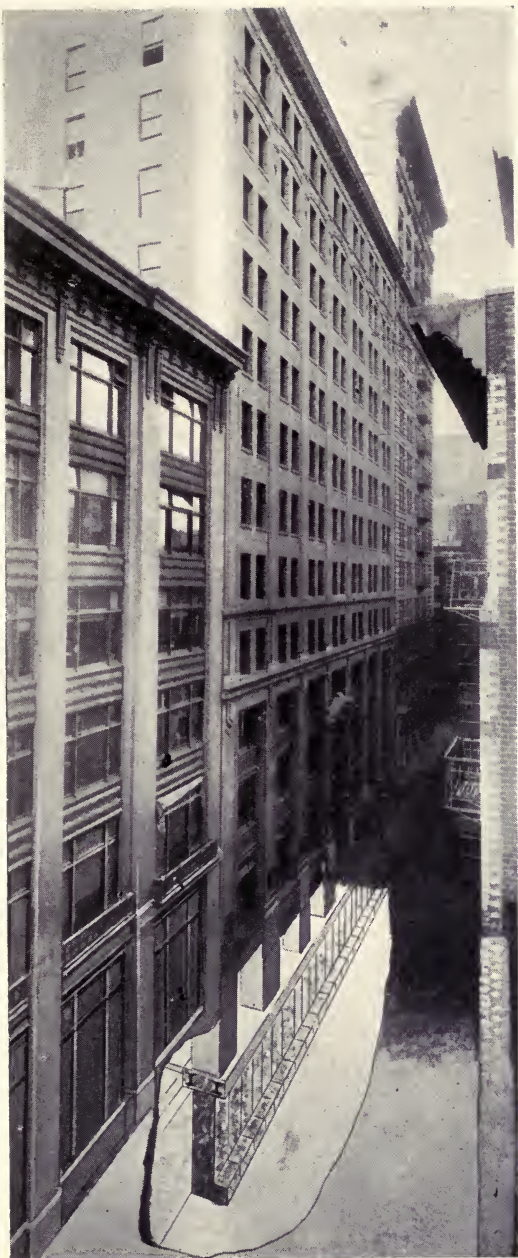
PLATE NO. 5. Building Supported on a Continuous Concrete Wall Built in
Four-foot Sections beneath a New Grillage
The wall also acts as sheeting for the excavation, and is twenty-five feet in
height

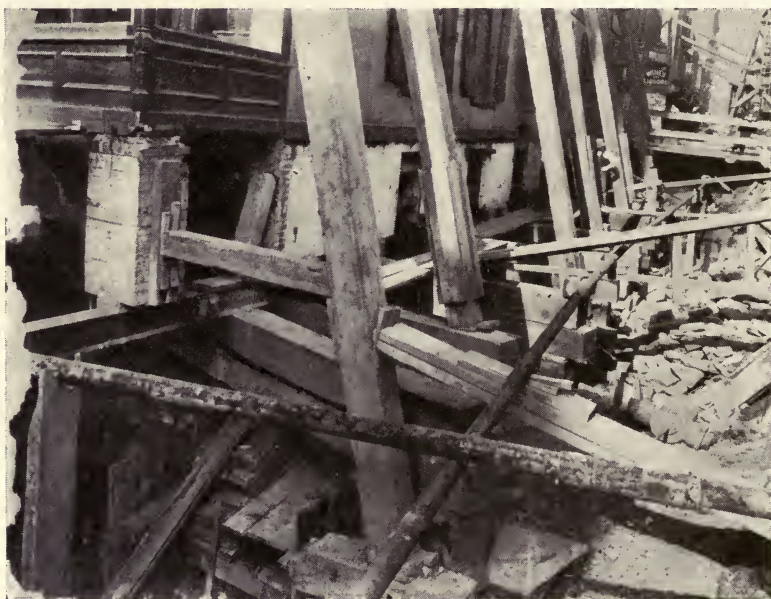
PLATE No. 6. Shores Used in 1902 during the Construction of Subway,
New York City

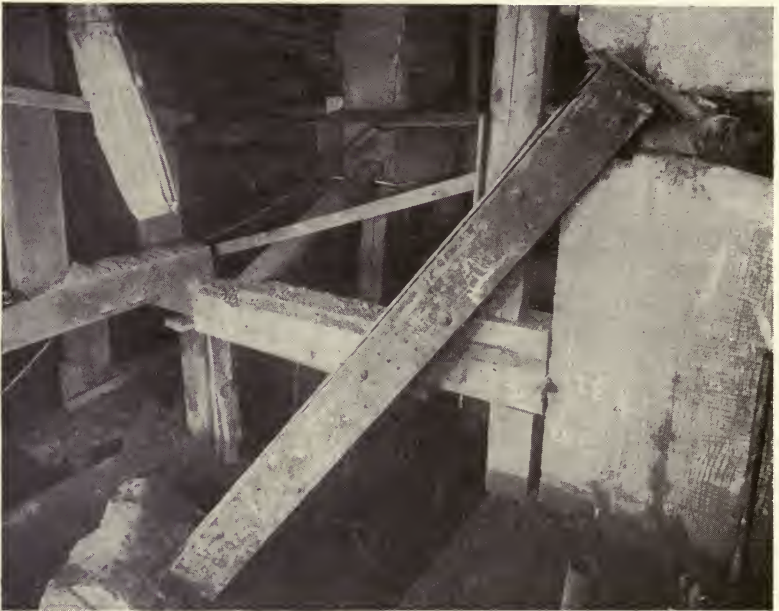
PLATE NO. 7. Composite Steel and Timber Shore

Steel channels are rigidly bolted to timber separator and wedged to foundation and concrete abutment

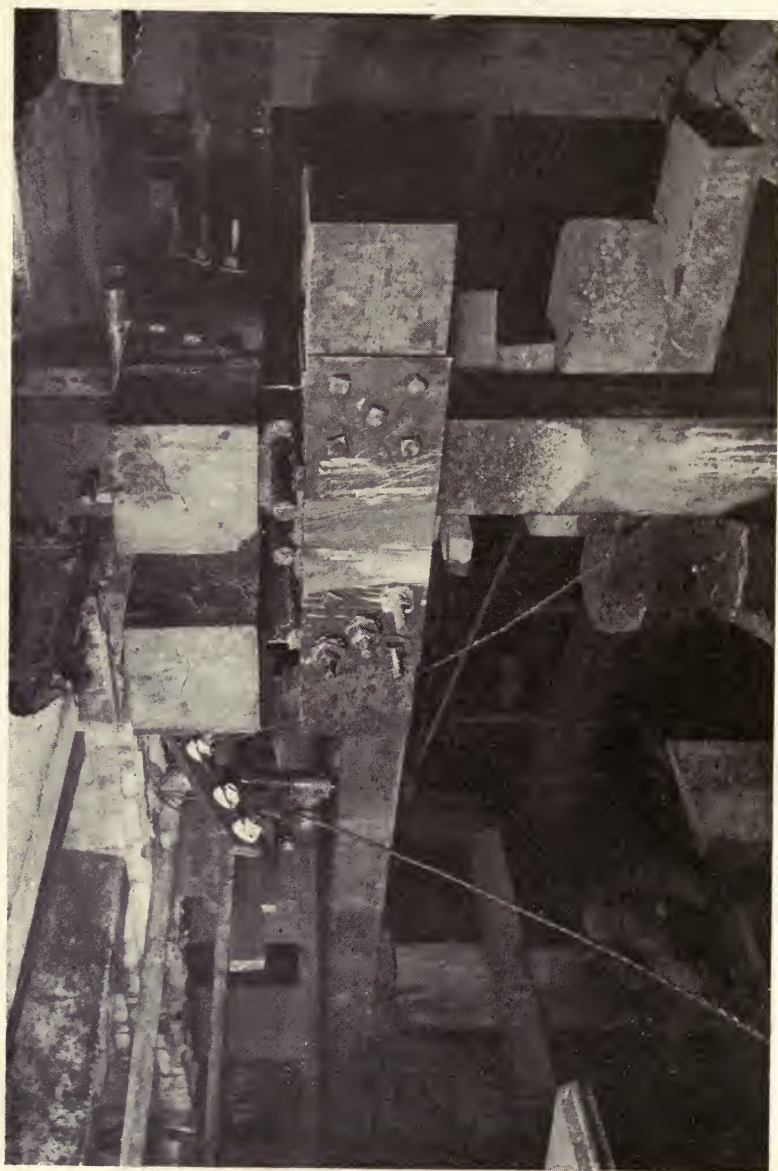
PLATE No. 8. Clamp on Square Cast-Iron Column of 250 Tons Load before Being Concreted in
The timber members are 12" x 12" oak. Note the steel pins in holes bored through the column

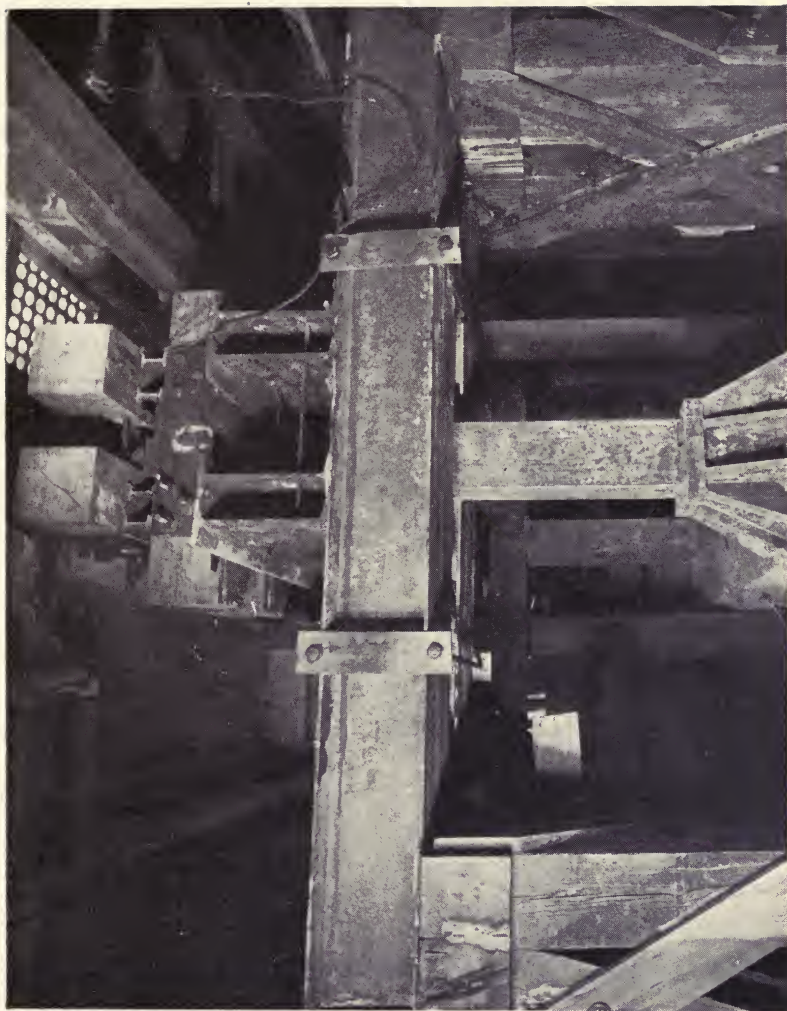
PLATE NO. 10. Method of Needling 250-Ton Cast-Iron Columns. Detail of column clamp shown on Plate No. 8. Note timber towers, with oak caps, and composite needle-beams as shown on Plate No. 11

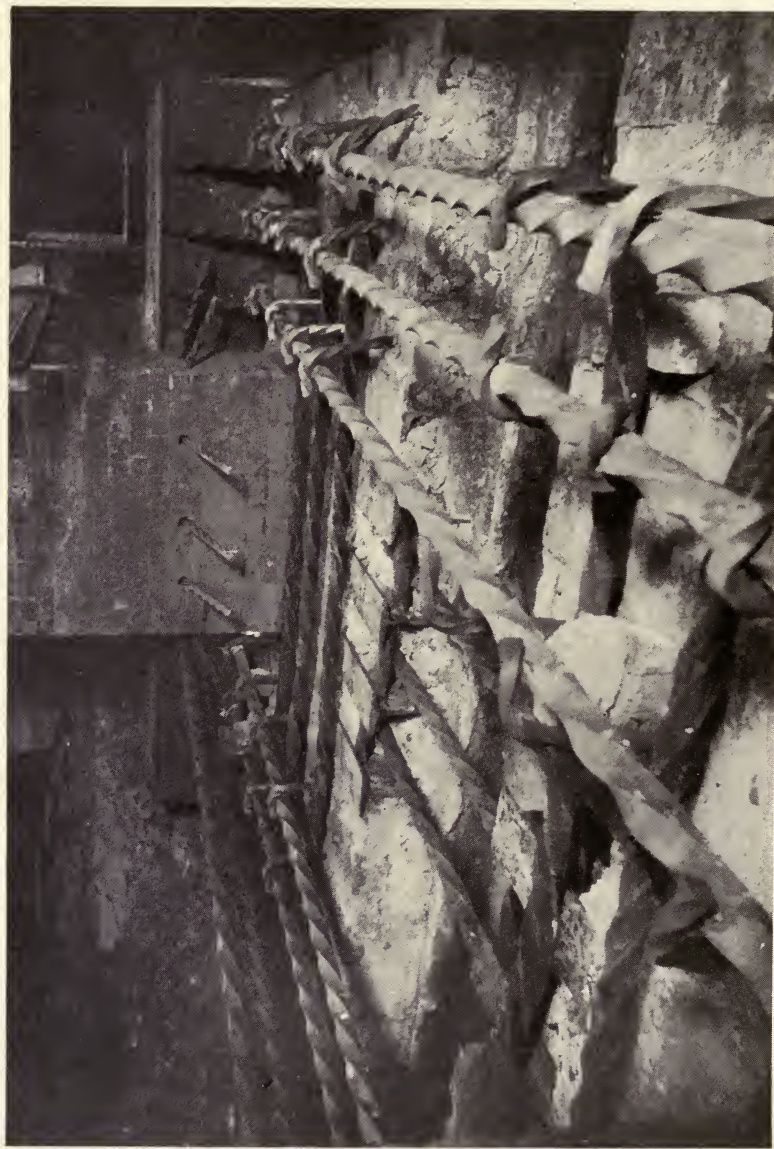
PLATE No. 12. Reenforcing Rods Placed for the Grillage in the Woodbridge Building, 100 William Street
The column loads are about 435 tons each

This building, a thirteen-story structure, approached very closely to the subway structure, necessitating the underpinning of its front wall, carried by eight columns, each loaded with about 435 tons. Each column was founded upon a grillage consisting of two layers of I-beams, the lower one paralleling the building front. These grillages approached within three or four feet of each other. To diminish the risks of underpinning an additional grillage was decided upon, although it was considered quite feasible to underpin each grillage individually, as they were of generous proportions.

First the I-beams were well stripped of their enveloping concrete, exposing the sides of the outside I-beams of the upper row and the ends of the lower row as shown on Plate 12. Next holes were drilled in the concrete between the beams for a great number of hooked dowels which were grouted in. Then $1\frac{1}{2}$ -inch rods were cut to fit the spaces of the upper row of I-beams. Rods were also placed in the gaps of the lower row, their ends being supported by short rods wedged between the I-beams, and inclined rods were butted against the upper flanges of the upper I-beams. The cutting of the rods was easily accomplished with the acetylene torch. A form was set up and all the steel thoroughly embedded in a generous block of rich concrete. This grillage took

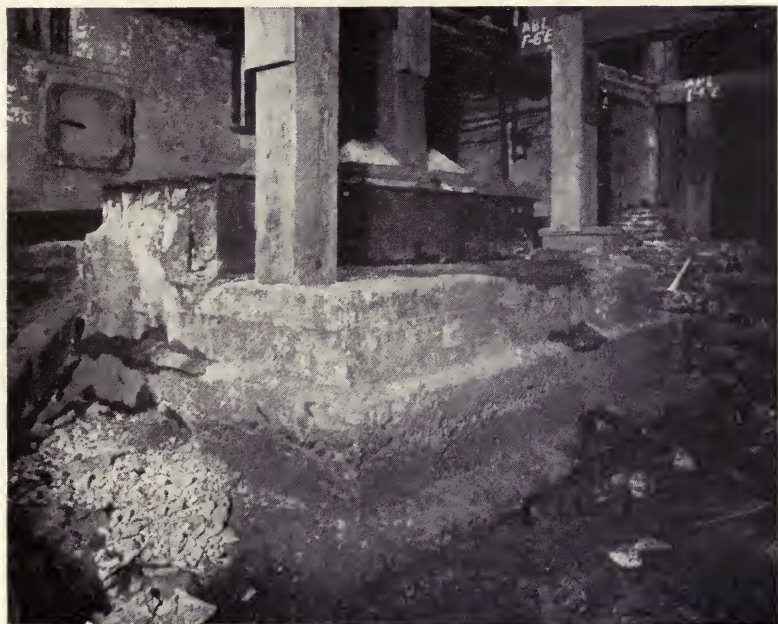
PLATE No. 13. Original Footing of One of the Columns of the Kuhn-Loeb Building, 52-54 William Street

Below upper beams is another layer of I-beams, then 30" of foundation concrete resting on fine sand

The two columns at the south end rested upon a huge "cantilever" girder, in turn resting upon a transverse layer of 18-inch I-beams. The other columns of the front row were founded upon a layer of 20-inch I-beams resting upon a transverse layer of 15-inch I-beams, which in turn were founded upon a 30-inch layer of concrete. This structure is clearly shown on Plate 13.

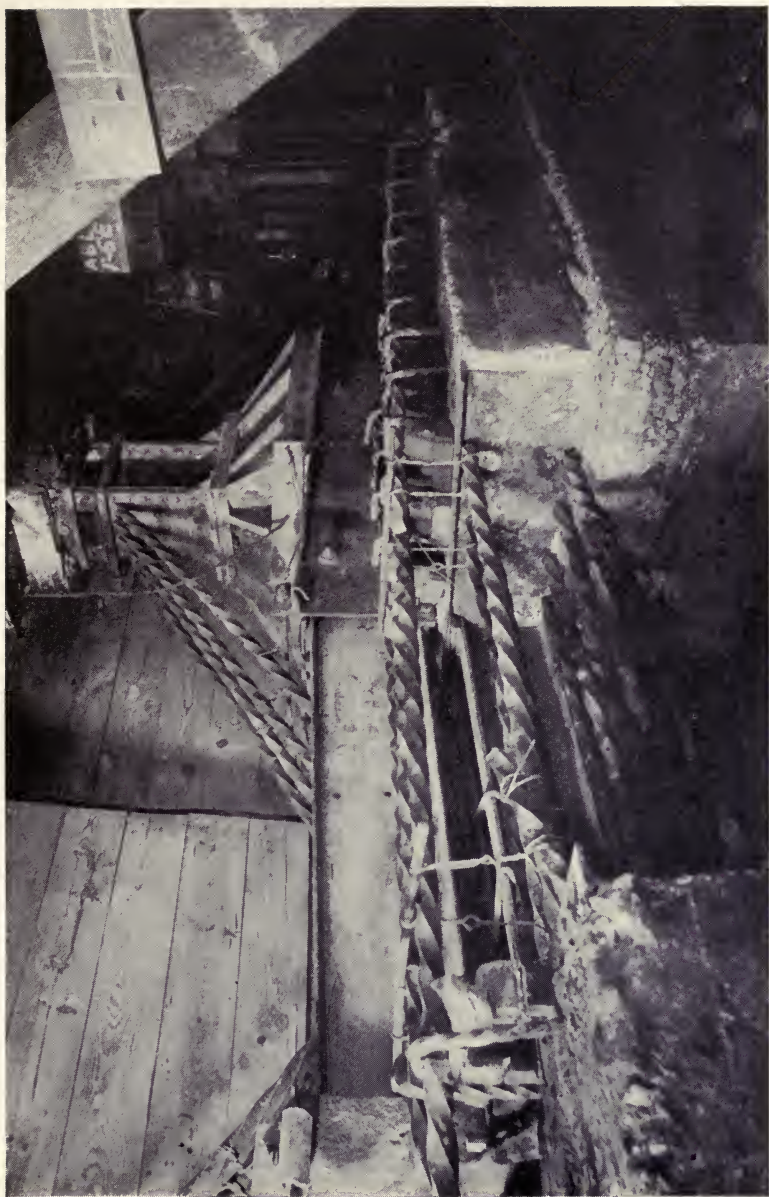
PLATE No. 14. Reenforcing Steel and I-Beams in the Grillage for the Twenty-one-Story Kuhn-Loeb Building
before Concreting

To make the layers of I-beams continuous, beams were cut with an acetylene torch to closely fit between the outside of the webs of the lower layer and others to overlap the ends of the upper layer. In addition hooked dowels and reenforcing rods were used to strengthen the outward projection of the grillage. To spread the column loads directly over the reenforced grillage, buttresses were built outward from the steel columns, which were stripped for the purpose. The resulting grillage, shown on Plate No. 14, was strong

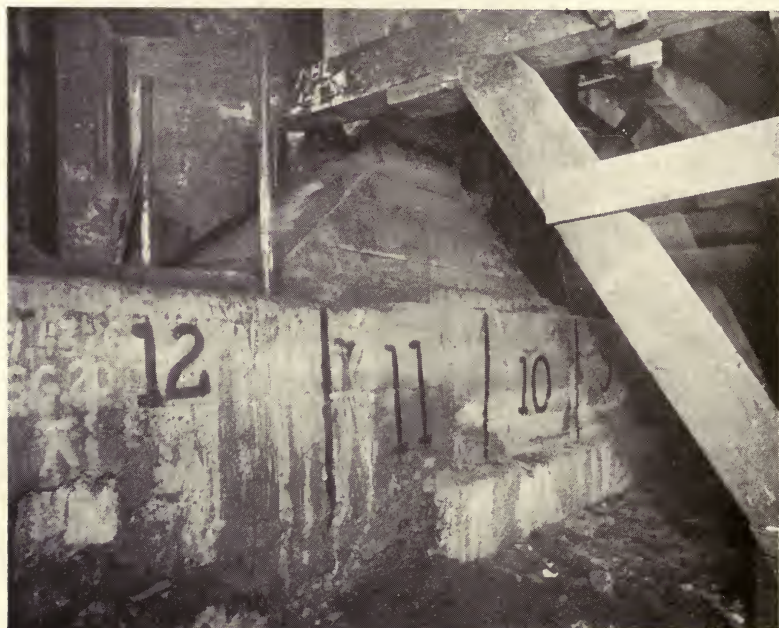
PLATE NO. 15. The Grillage of the Kuhn-Loeb Building after Concreting with Underpinning Piers Marked Out and Numbered
View is from same position as Plate No. 14

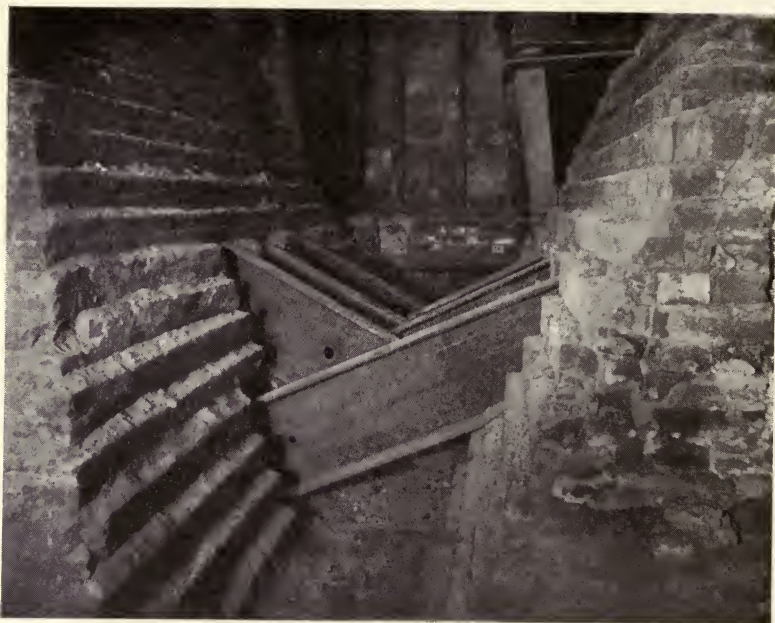
PLATE NO. 16. Crossed I-Beams between Brick Piers
The beams were placed in niches carefully cut for them and then securely concreted in

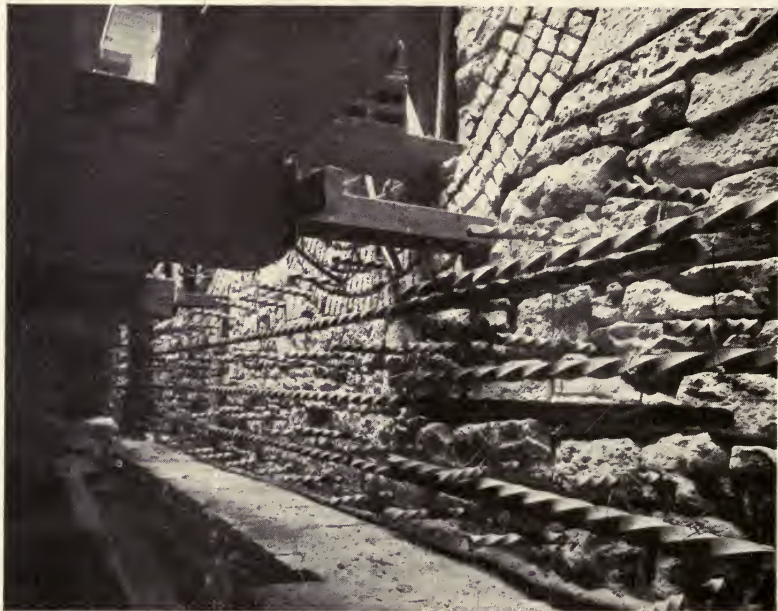
PLATE NO. 17. Reenforcement of Dowels and Rods
Used for reenforcing wall laid up in lime-mortar and subsequently concreted in. Bank of New York

Just previous to the introduction of steel frames to buildings, columns were commonly carried on heavy piers or pyramids of brickwork. By cutting niches into those to be underpinned, inserting heavy crossed I-beams and concreting them in, the piers may be connected rigidly, as shown on Plate No. 16, and then are readily underpinned. An older type of foundation, and one which gives excellent results, is the continuous masonry wall laid up in a trench. Often these walls, though adequate for their purpose, are not sufficiently strong to stand the stresses of underpinning operations. By scraping out their joints, inserting dowels and longitudinal reenforcing rods or beams, and concreting them in with a rich mixture, the walls are readily reenforced, as in the case of the Bank of New York, shown on Plate No. 17.

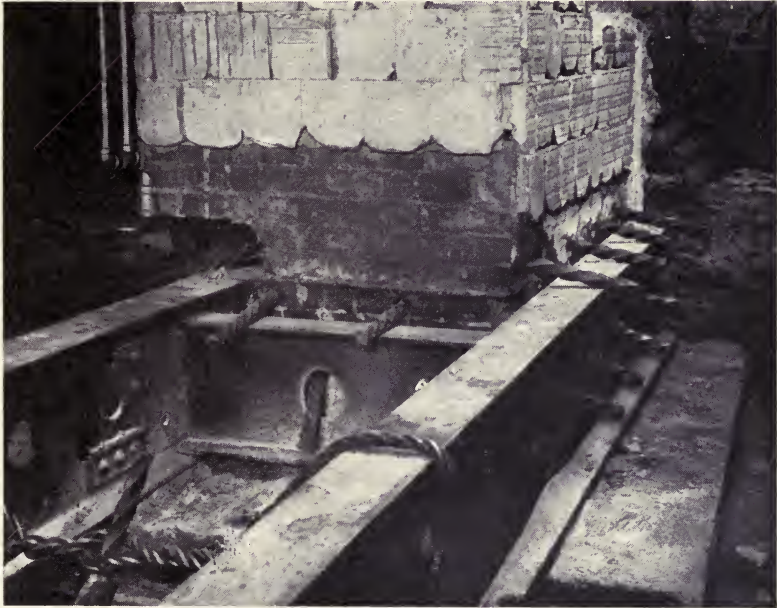
PLATE NO. 18. Grillage Detail for Brick Pier of Typical Small Building
Showing Beams and Dowels

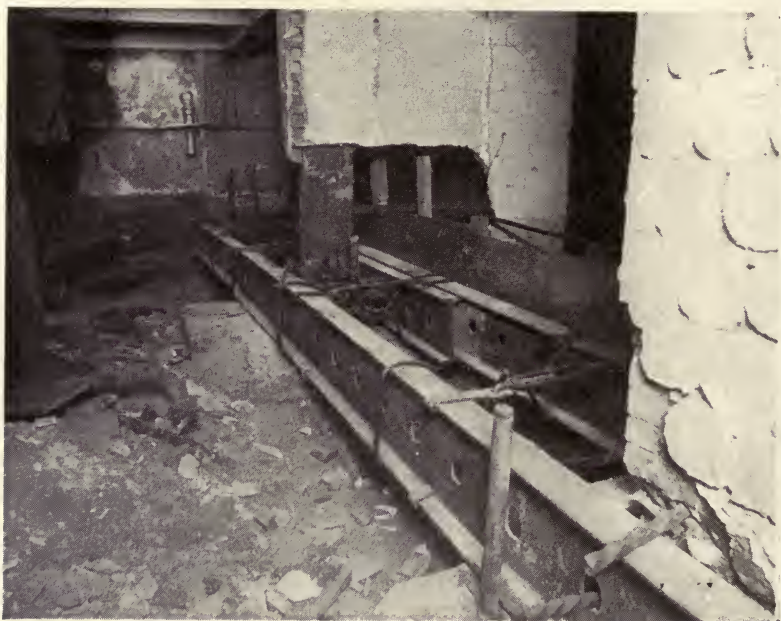
PLATE No. 19. Typical Steel Grillage for Small Building, Showing Beams, Cross-Ties, Dowels, etc., before Concreting

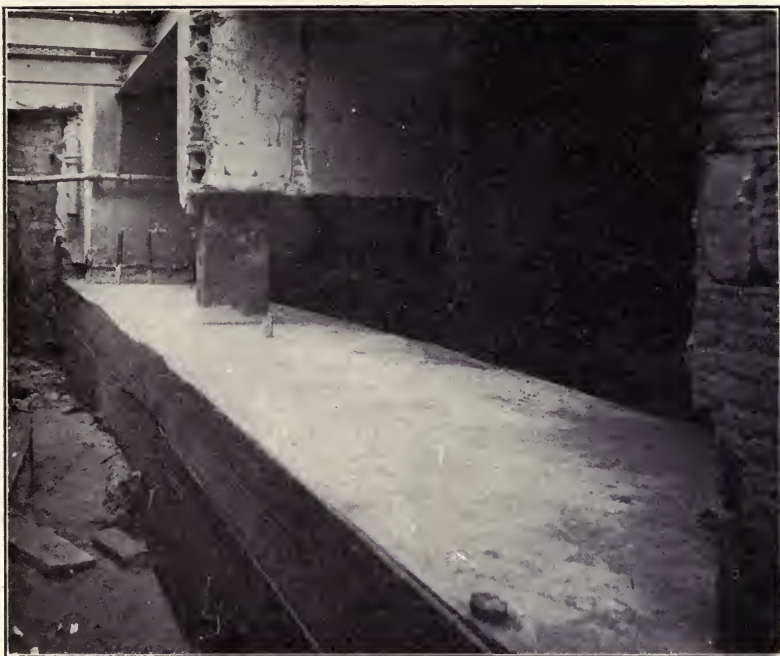
PLATE NO. 20. Typical Grillage for Small Building after Concreting, Showing Small Pipes Left for Grouting the Underpinning Piers
View from same position as Plate No. 19

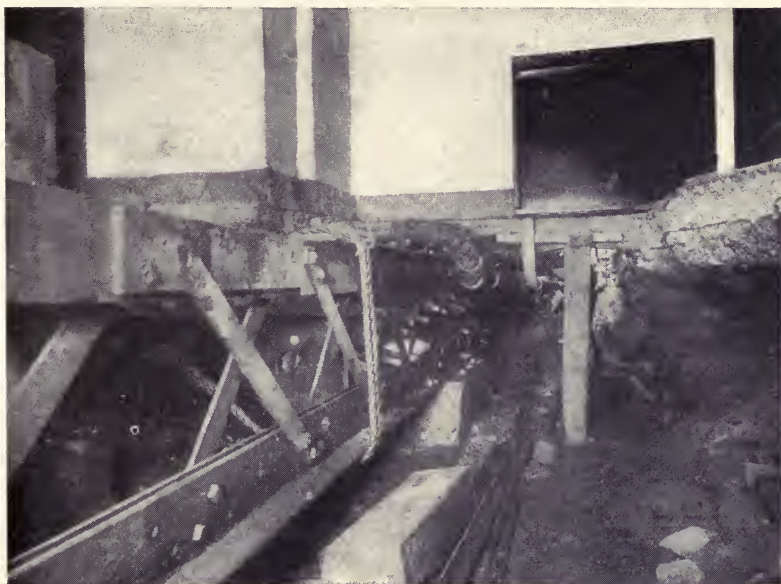
PLATE NO. 21. Showing the Use of Lattice Girders for Grillage Purposes before Concreting
Lattice girders are useful when space is too small to place long beams

Lattice girders have been extensively used for grillages. They have the advantages of being continuous and readily connected together in tight places. Such a use of a lattice girder at 123 William Street

is shown on Plate No. 21. Here the interior girder was placed under a barber-shop floor which was tunneled under and supported by I-beam props. The advantages of the lattice girder have been largely lost since the acetylene torch for cutting steel has come into extensive use. With an assortment of

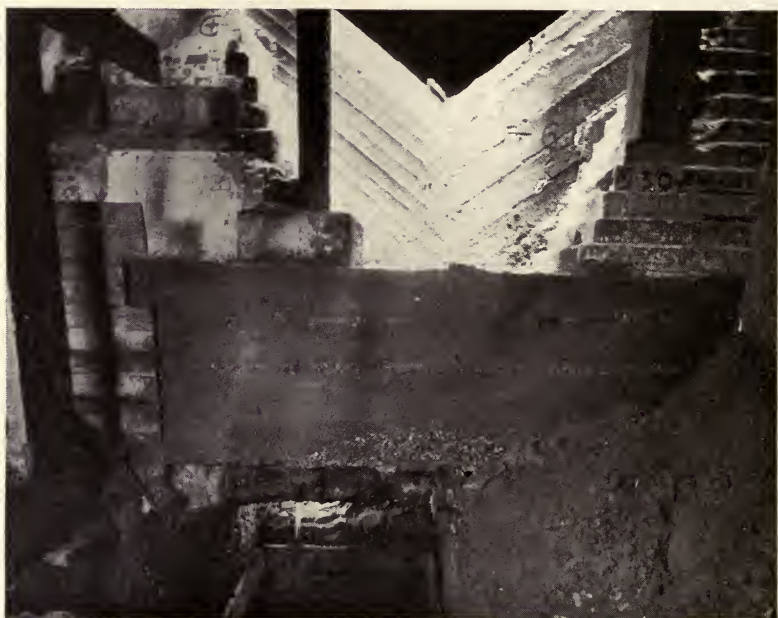
PLATE NO. 24. Showing Start of Underpinning Pit under Spread Footing.
Crossed 15" I-beams are embedded in concrete between brick piers
Pit is for the purpose of providing space and head room to drive and wedge
piles to foundation

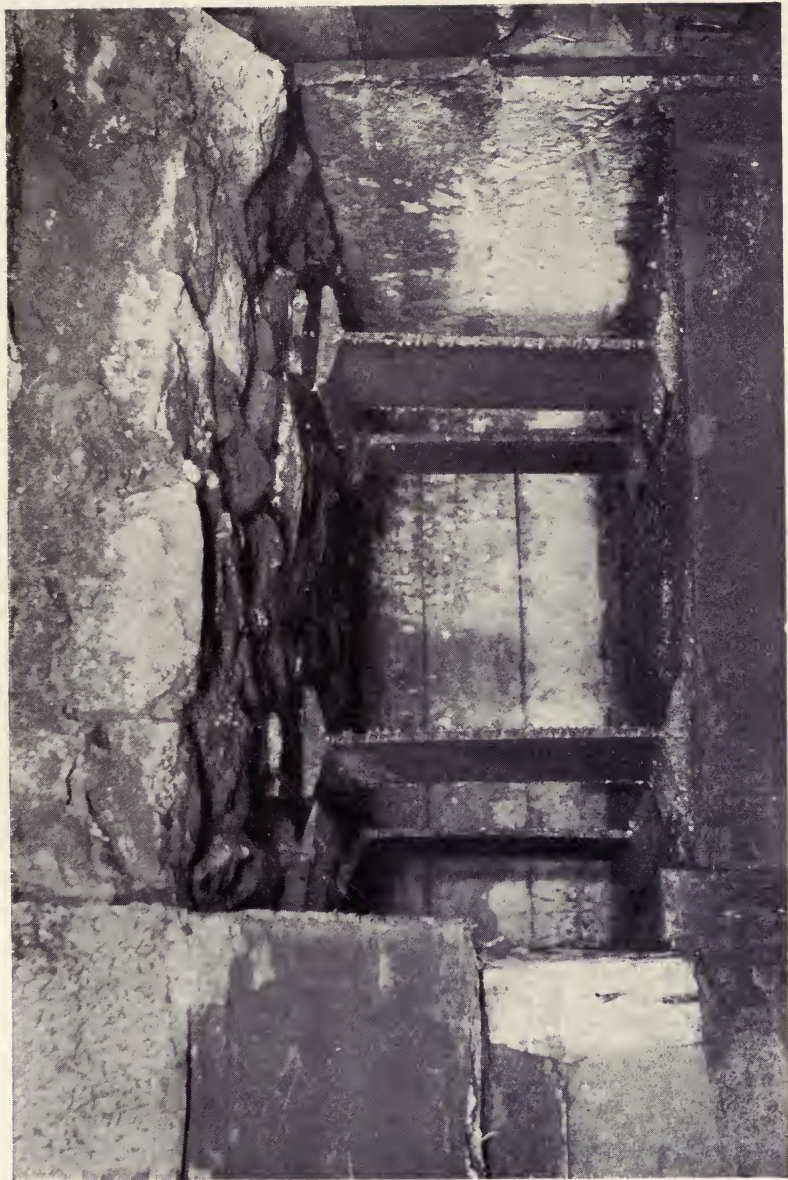
PLATE No. 25. Method of Transferring Column Load from Old Foundation or New Grillage to New Underpinning,
Concrete Pier (4' x 4' Square) with Short I-Beams and Wrought-iron Wedges

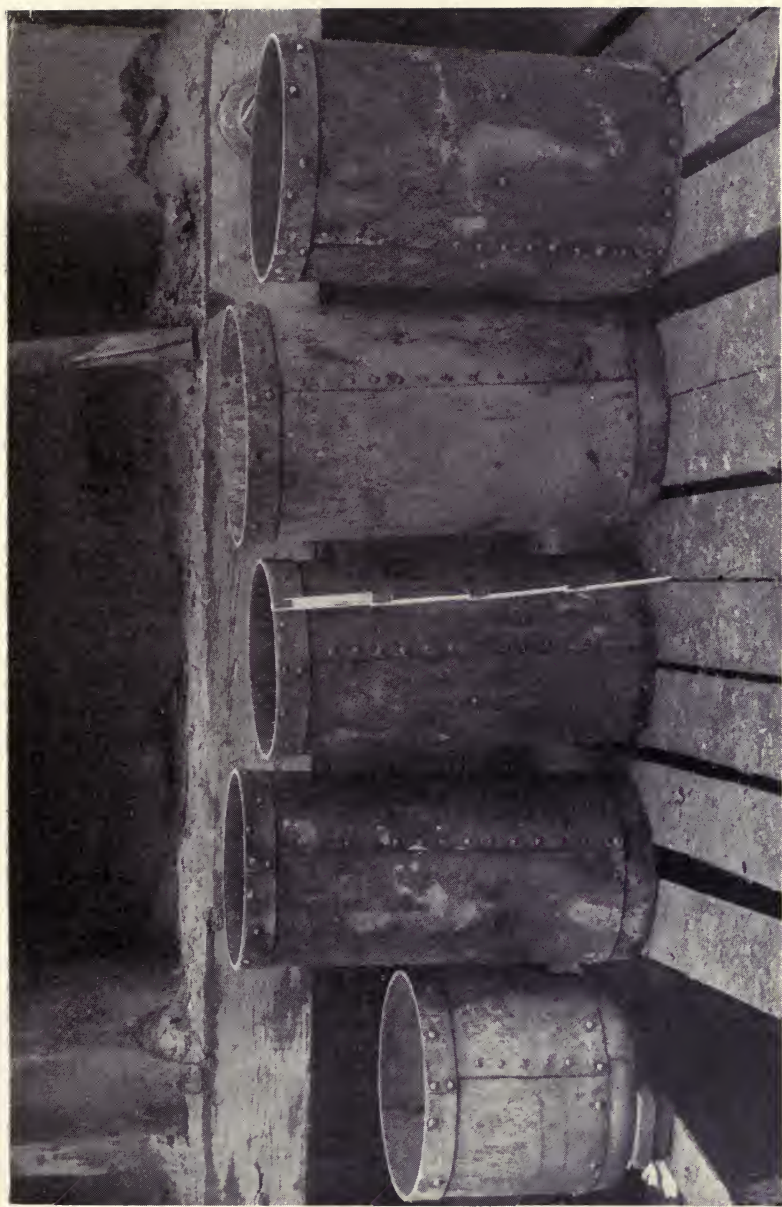
PLATE No. 27. A Good Type of Riveted Steel Pipe for Underpinning Purposes

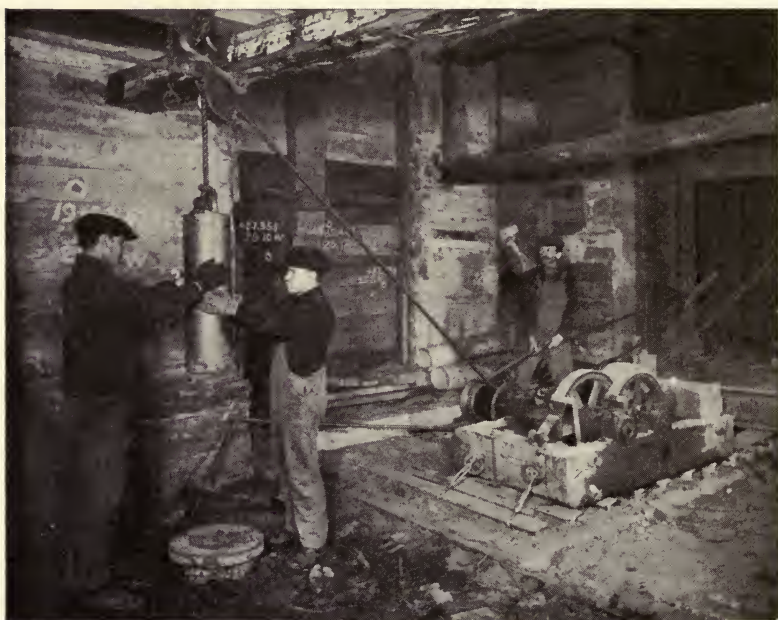
PLATE NO. 28. Pile-Hammering Rig

a drop-hammer rig. This consists of a "nigger-head" winch, a few snatch blocks, a graphite lubricated hemp rope and a hammer about 9 inches diameter and 400 or 500 pounds weight dropping 2 or 3

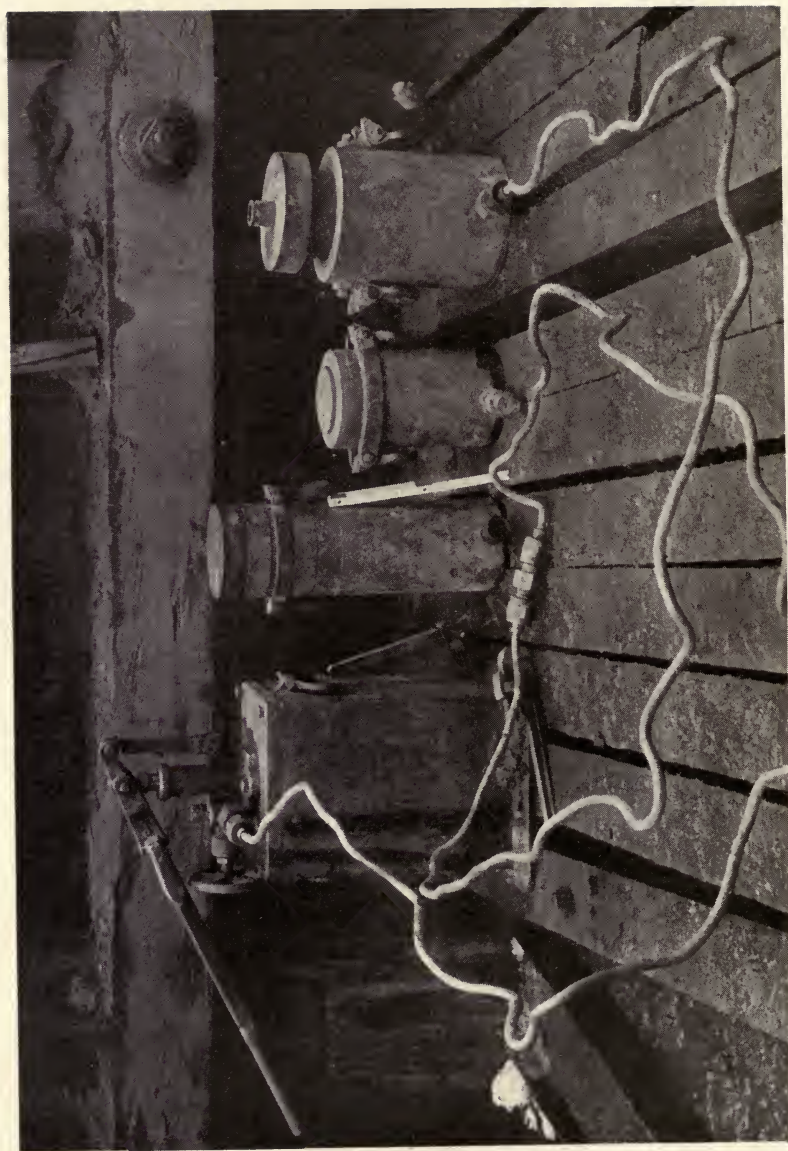
PLATE NO. 29. Jacking Rig, Consisting of Hydraulic Pump, Flexible Copper Pipe, and $4\frac{1}{2}$ " and 6" Diameter Hydraulic Rams. Normal hydraulic pressure, 6,000 pounds per square inch, but apparatus is good for 13,000 pounds per square inch pressure

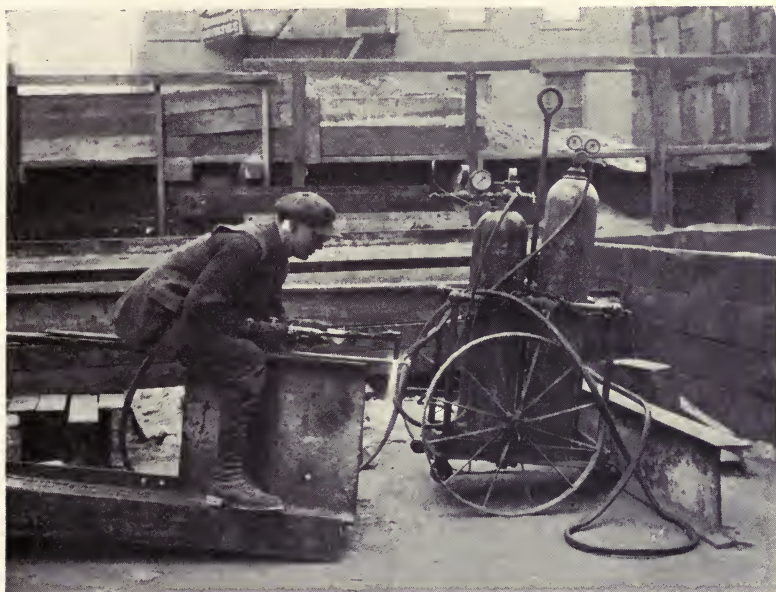
PLATE NO. 33. Burning Apparatus in Operation
Portable rig found to be very useful

An indispensable adjunct in underpinning operations is an apparatus for cutting iron and steel by means of a flame. This consists of a torch connected by means of two flexible armored hoses to tanks of

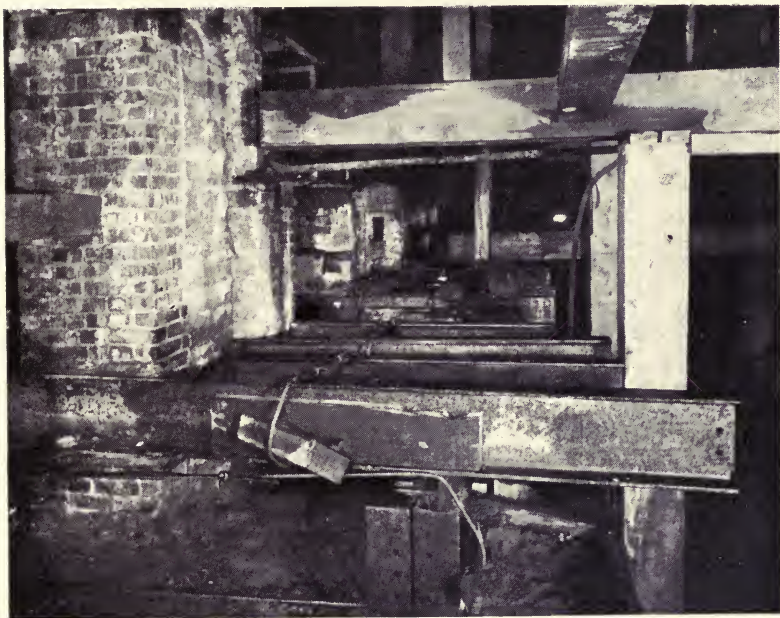
PLATE NO. 34. Showing Exterior Longitudinal 18" I-Beams and 15" I-Beam Needles with Lashings to Prevent Spreading

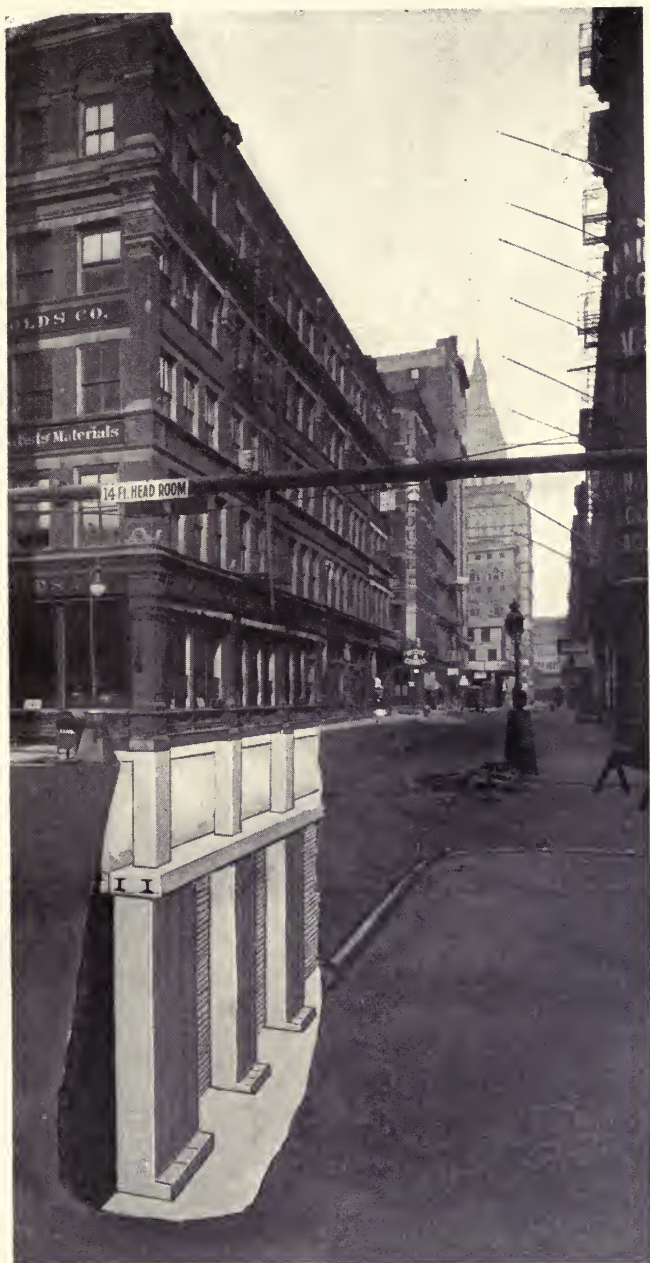
PLATE No. 35. 145-155 William Street, Showing Columns, Grillage,
Underpinning Piers, and Toe

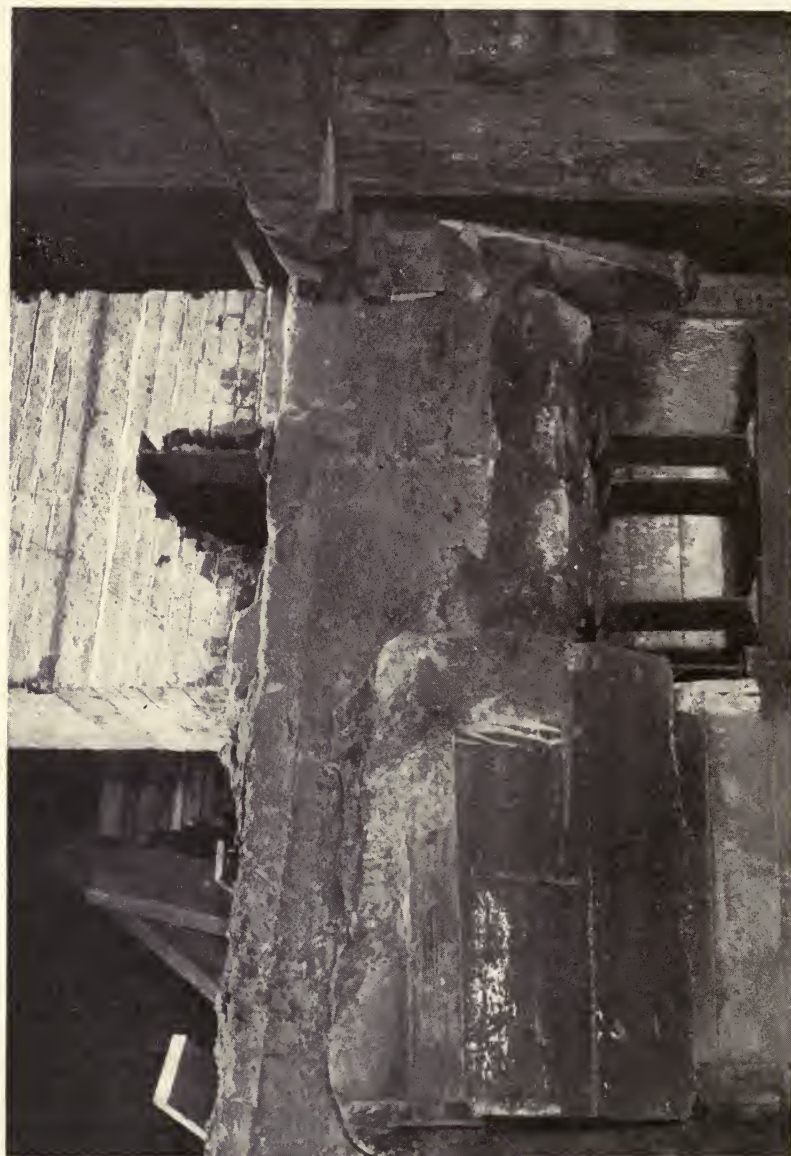
PLATE No. 37. Grillage and Underpinning Piers for 145-155 William Street.

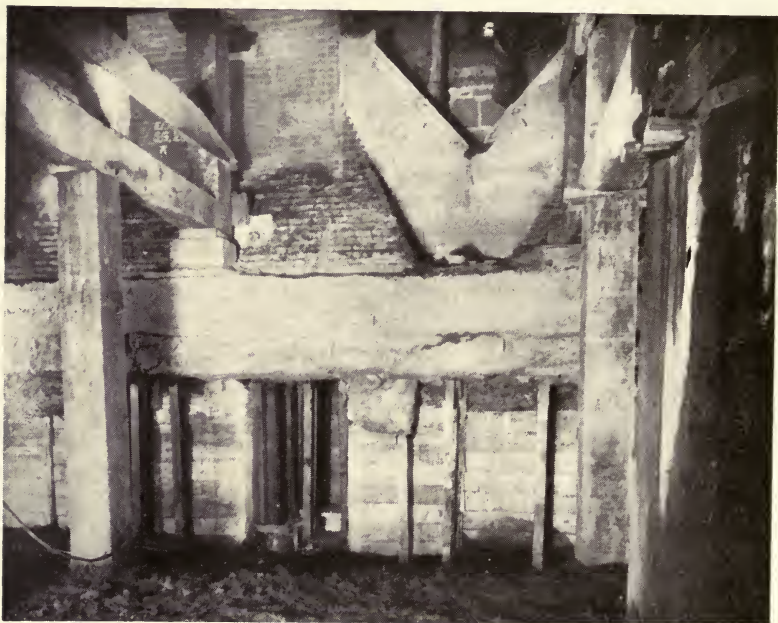
PLATE NO. 40. Showing Brick Columns, Continuous Concrete Base, V-Shaped Concrete Enclosing Crossed 15" I-Beams, and the Practically Completed Underpinning, Excavation for Subway Cut Started

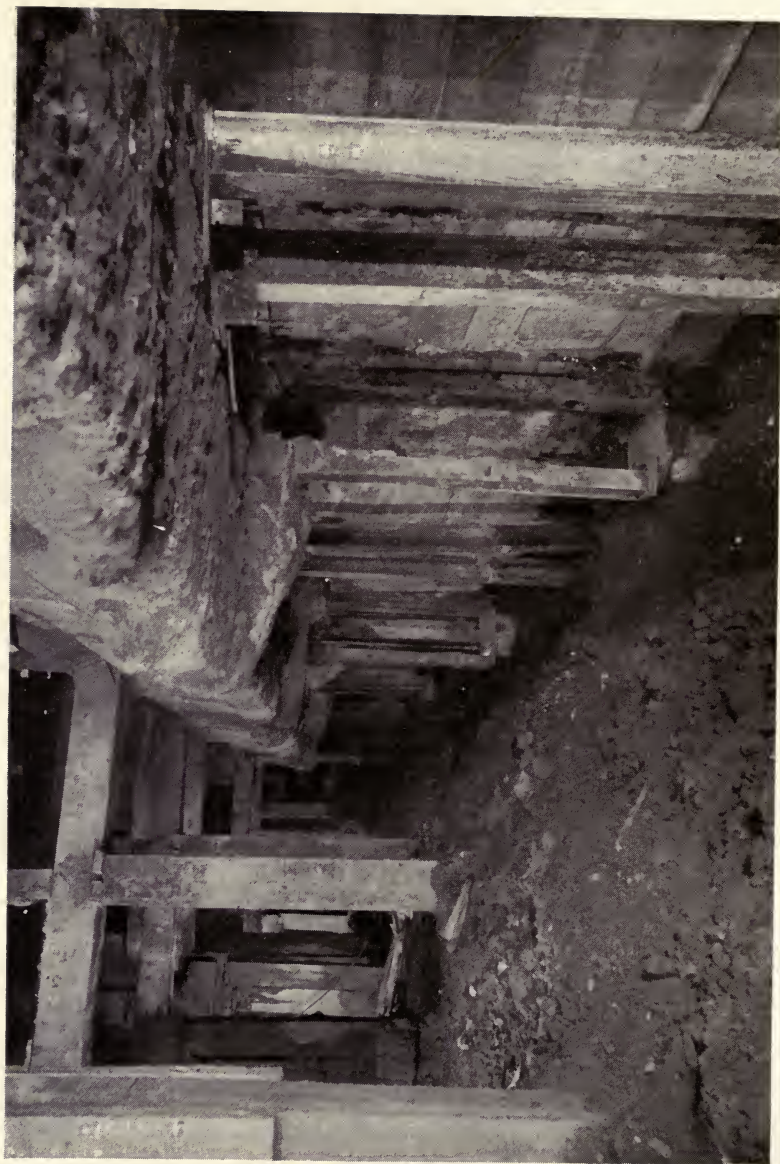
PLATE No. 41. Photograph of Bank of America. Showing overhang of the old original spread foundations, concrete containing wedging and temporary piles after partial excavation. Completed excavation is about 15 feet deeper

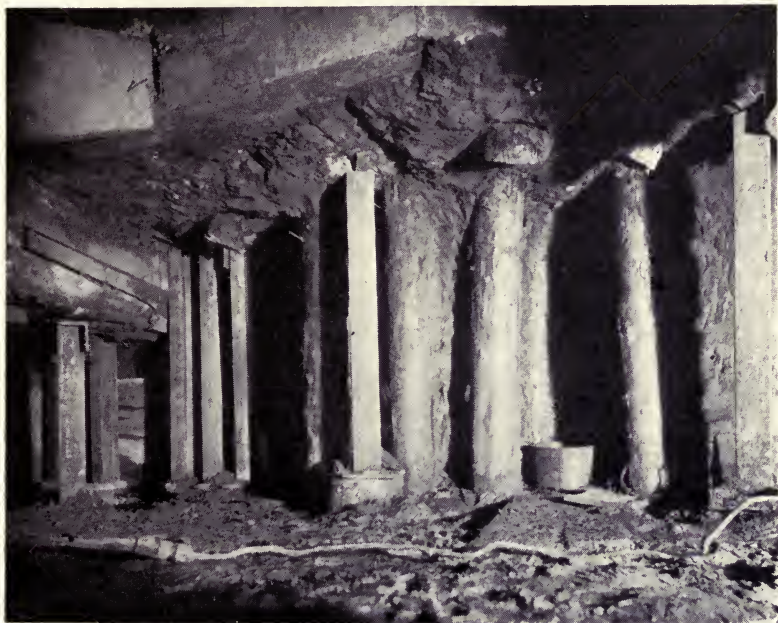
PLATE No. 43. Showing Substitution of 14" Steel Concrete Piles for Old Wooden Ones Which Had to Be Removed in the Lord's Court Building

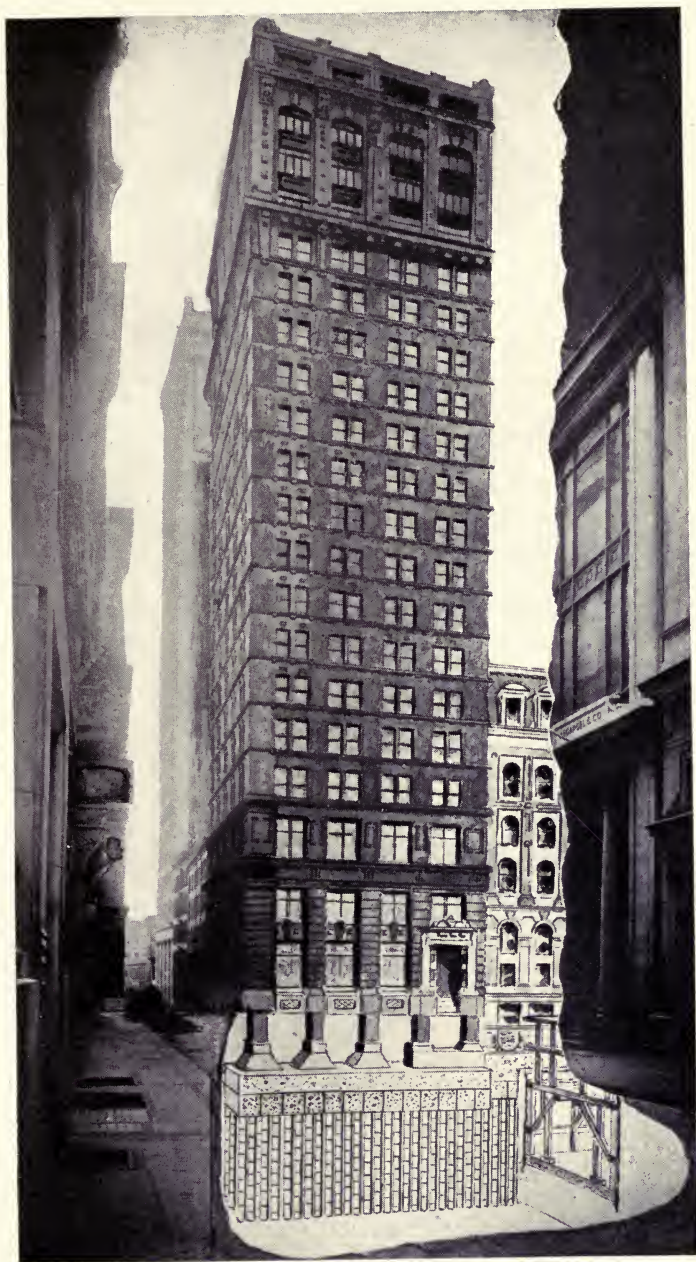
PLATE NO. 45. Kuhn-Loeb Building, Showing Its Underpinning
For details see Plate No. 42
